HIGHWAY RESEARCH REPORT

DYNAMIC TESTS OF THE CALIFORNIA TYPE 20 BRIDGE BARRIER RAIL SERIES XXIII

70-15

NO. M & R 636459

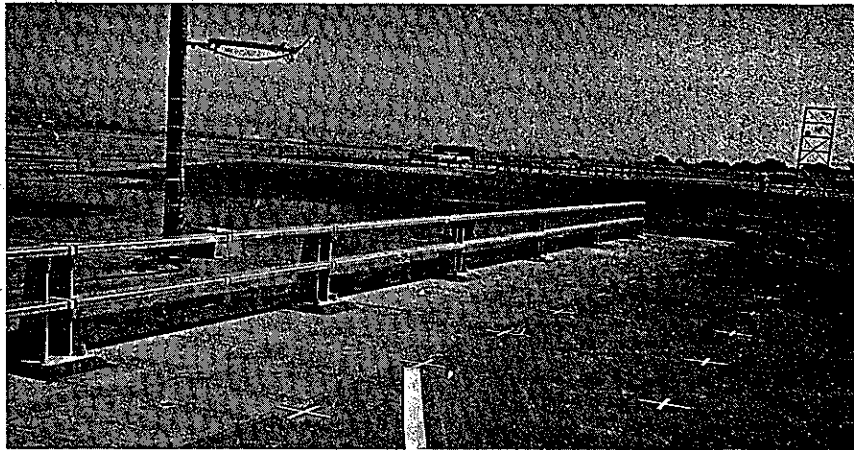
FIGURE 2

These considerations led in 1965-66 to the design, testing, and subsequent use of the California Type 8 Bridge Rail³ (Figure 2, below). This design is composed of two 2- by 6-inch steel rectangular tube rails mounted 15-inches and 27-inches high on welded, open-type steel posts spaced 10-ft. on centers.

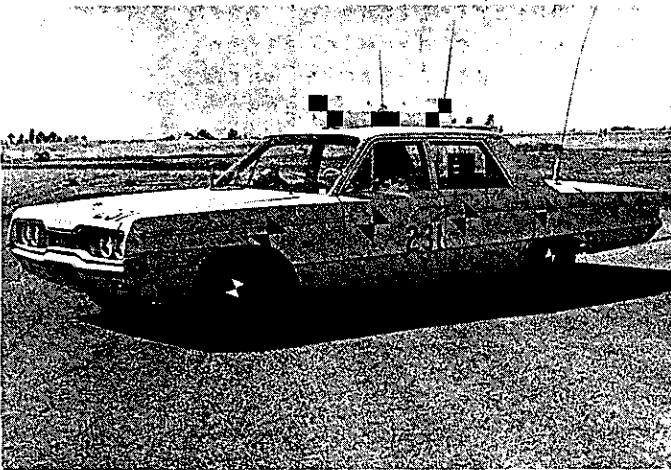
FIGURE 6

Maximum vehicular rise was approximately 16 inches. There was minor sheet metal damage sustained by the test vehicle and slight surface cracks sustained by the barrier (see Figures 6 and 7 below). No determination of the electronically measured deceleration could be made due to the poor quality of the instrumentation data. See the following page for additional test data, information, and photographs.

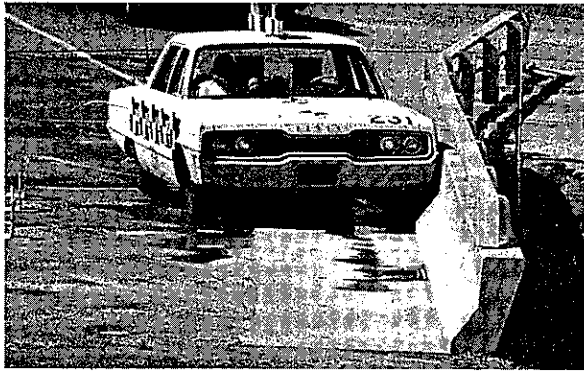
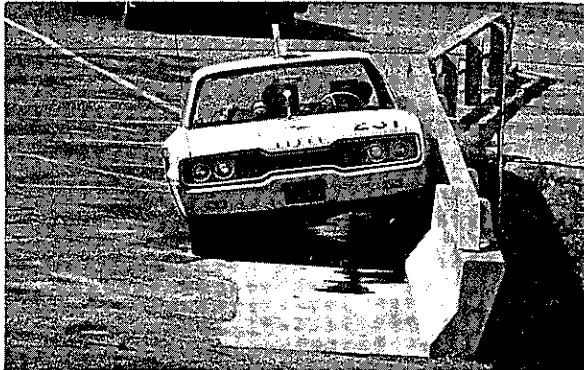
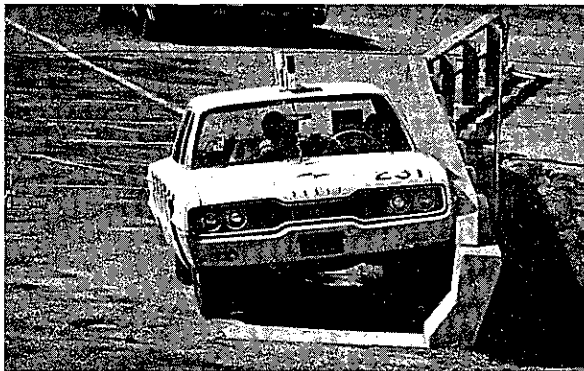
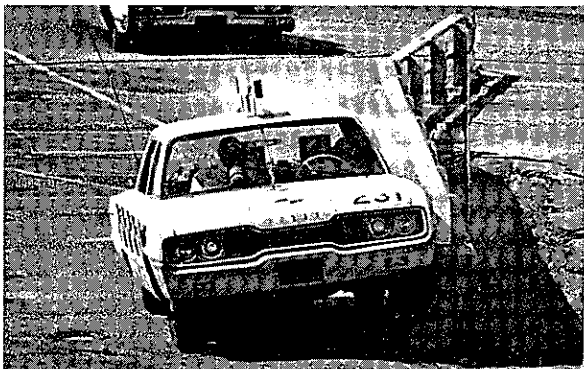
BARRIER TESTED Type 20 Bridge Rail
 LENGTH OF INSTALLATION 67' ±
 PASSENGER COMPARTMENT DECEL. Long. *
 (Highest 50 ms average) Lat. *
 MAXIMUM VEHICLE RISE 16"
 EXIT ANGLE 0°
 BARRIER DAMAGE Negligible
 *EXCESSIVE INTERFERENCE IN SIGNAL.

TEST NO. 231
 DATE 10-2-69
 VEHICLE 1966 Dodge Sedan
 SPEED 45 mph
 IMPACT ANGLE 7°
 VEHICLE WEIGHT 4980 Lbs
 (Incl. dummies & instrumentation)
 DUMMY RESTRAINT Lap Belt

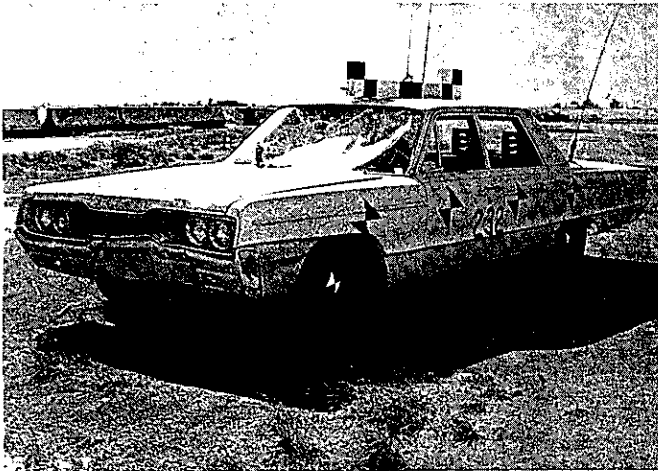
FIGURE 8

The same vehicle used for Test No. 231 was used for Test No. 232 with no repairs. Test No. 232 was also a 7 degree impact but the impact velocity was increased to 66 mph. Impact was again about 27.5 feet from the upstream end of the test barrier. After impact, the vehicle traveled along the barrier for 27 feet and then left the barrier at an exit angle of 1 degree. During this test the maximum vehicle rise was 16 inches. Vehicle damage was very minor, and there was no significant structural damage sustained by the barrier (see Figures 8 and 9 below). The damaged windshield and grill were caused by a second collision with a section of scaffold. A maximum 50 ms average deceleration of 4.8 G's lateral (average of 2 data channels) was measured on the floor of the vehicular passenger compartment. This deceleration did not exceed the tolerance level, as defined in Appendix A, for a lap-belted occupant. None of the longitudinal deceleration data was considered accurate. See the following page for additional test data, information, and photographs.

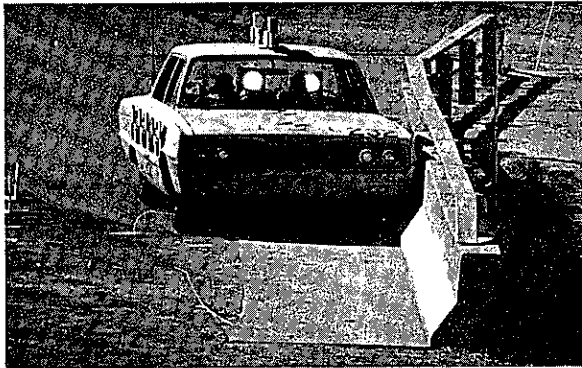
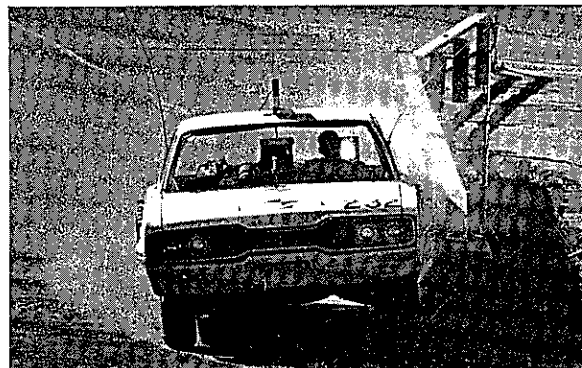
BARRIER TESTED.....	Type 20 Bridge Rail	TEST NO.	232
LENGTH OF INSTALLATION	67' ±	DATE	10-2-69
PASSENGER COMPARTMENT DECEL. (Highest 50 ms average)	Long. 4.8 G's Lat. *	VEHICLE	1966 Dodge Sedan
MAXIMUM VEHICLE RISE	16"	SPEED	66 mph
EXIT ANGLE	1°	IMPACT ANGLE	7°
BARRIER DAMAGE	Negligible	VEHICLE WEIGHT	4980 Lbs (Incl. dummies & instrumentation)
* ERRONEOUS DATA		DUMMY RESTRAINT	Lap Belt

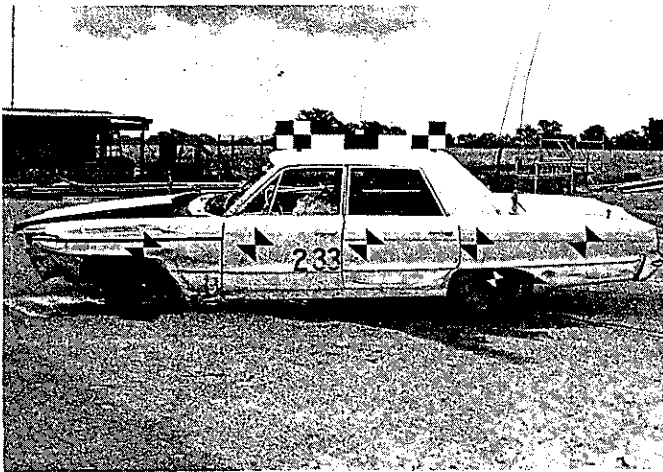
FIGURE 10

The vehicle used for Tests 231 and 232 was again re-used for this test, a 64 mph, 15 degree impact. Impact occurred about 27.5 feet from the upstream end of the barrier. After maintaining contact with the barrier for approximately 19 feet, the test vehicle left the barrier at an exit angle of 10 degrees. Vehicle rise was small as it appeared that the steel railing held the test vehicle down during the redirection. This penetration underneath the steel railing is indicative of the decreasing effect of the contoured concrete surface at larger impact angles. There was no tendency for the vehicle to roll or jump. The left front end and undercarriage of the vehicle were severely damaged (see Figure 10 below). Minor spalling of the concrete parapet also occurred (see Figure 11 below). No measurement of vehicular or dummy deceleration was obtained due to an apparent instrumentation malfunction. See the following page for additional test data, information, and photographs.

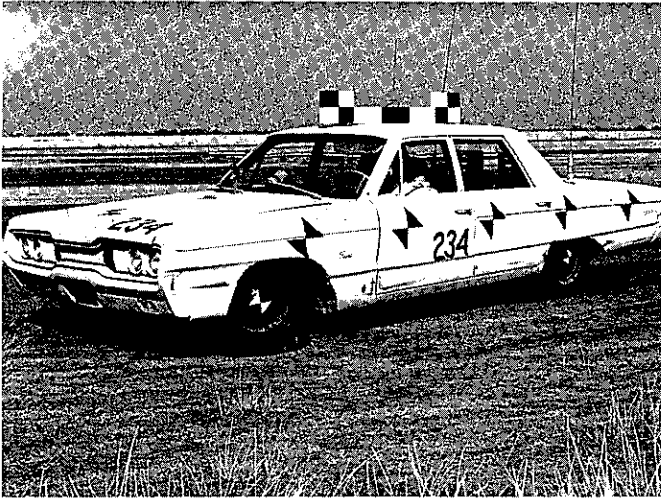
FIGURE 14

Vehicle damage was limited to minor scrapes along the left side (see Figure 14 below). Barrier damage was very minor (see Figure 15 below). The maximum 50 ms average decelerations measured on the floor of the vehicular passenger compartment were 4.8 G's lateral (average of 2 data channels) and less than 1 G longitudinal (average of 3 data channels). These vehicular decelerations did not exceed the tolerance levels, as defined in Appendix A, for a lap belted occupant. Thus, a lap belt restrained occupant would have sustained little or no injuries. The maximum 50 ms dummy decelerations measured were 6.5 G's lateral and 2.3 G's longitudinal. See the following page for additional test data, information, and photographs.

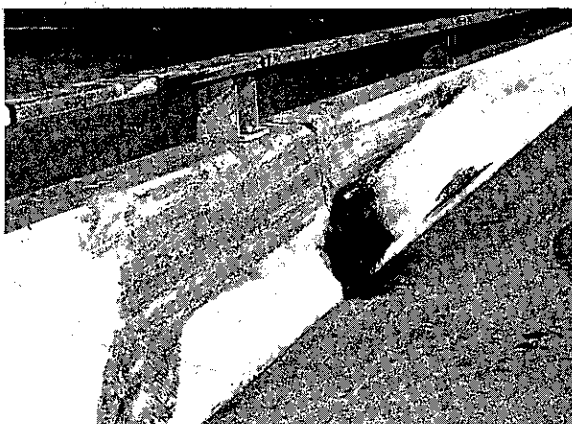
FIGURE 16

Spalling of the concrete in the vicinity of impact and a slight permanent deflection (0.1 ft.) of the steel railing indicated the severity of the impact (see Figure 16 below). The concrete portion of the barrier railing sustained a vertical crack approximately 1/16-inch wide that extended from the deck to the top of the parapet. This crack was at a point just upstream from impact. Displacement of the concrete parapet was approximately 1/8-inch at the top of the expansion joint.

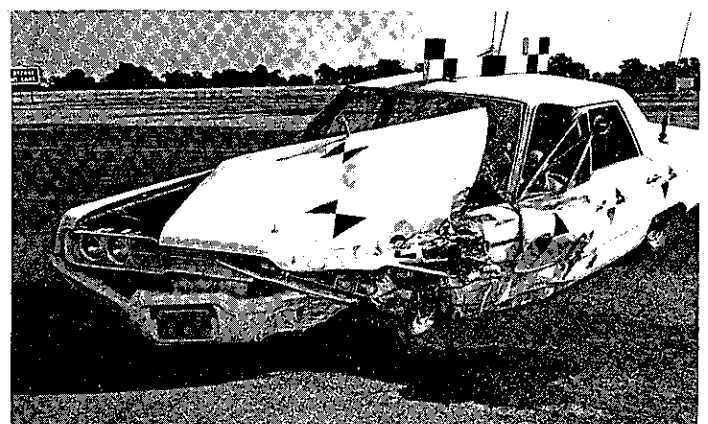
FIGURE 17

As could be expected with any 25 degree impact into a rigid barrier, vehicular damage was severe (see Figure 17 below).

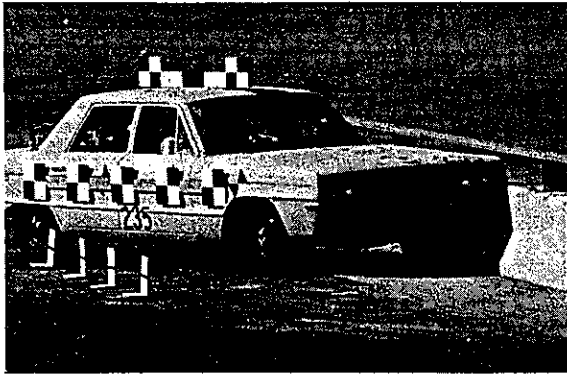
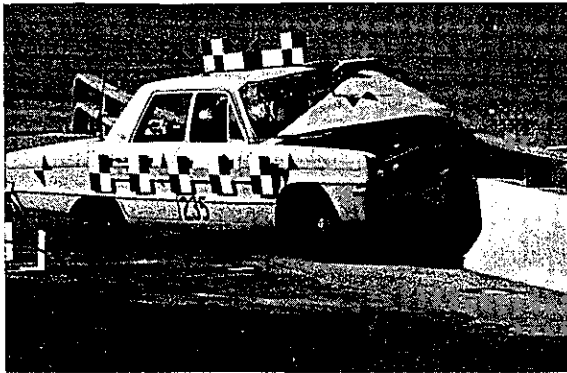
TEST NO.	235
DATE	10-29-69
VEHICLE	1966 Dodge Sedan
SPEED	66 mph
IMPACT ANGLE	25°
VEHICLE WEIGHT	4900 Lbs†
(Incl. dummies & instrumentation)	
DUMMY RESTRAINT	Lap belt

BARRIER TESTED	Type 20 Bridge Rail
LENGTH OF INSTALLATION	67'±
PASSENGER COMPARTMENT DECEL. (Highest 50 ms average)	14.8G's 9.1 G's
MAXIMUM VEHICLE RISE	Negligible
EXIT ANGLE	3°
BARRIER DAMAGE	Minor
† VEHICLE GAS TANK REMOVED
